Product Application Bulletin

POLYUREA

Tile Lined Tank Rehabilitation

Project: Sodium Chlorate holding tank. Repair tiles and tile joints in a tank originally scheduled for demolition. Steel tank members and the repaired tank tile liner were spray coated.

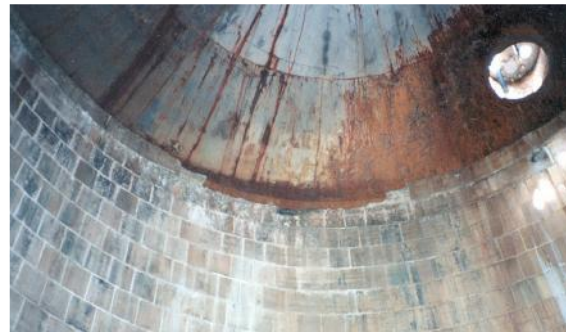
Interior Prior to Rehabilitation

Restoral Systems performed the interior repairs, blasted the tank, both steel and tile, and installed the FSS 45DC polyurea spray liner.

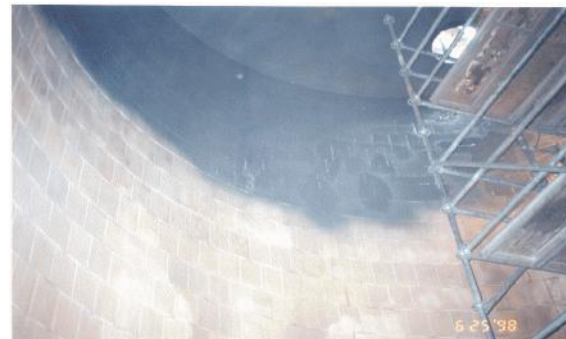
Coating Steel Roof and Tile Area

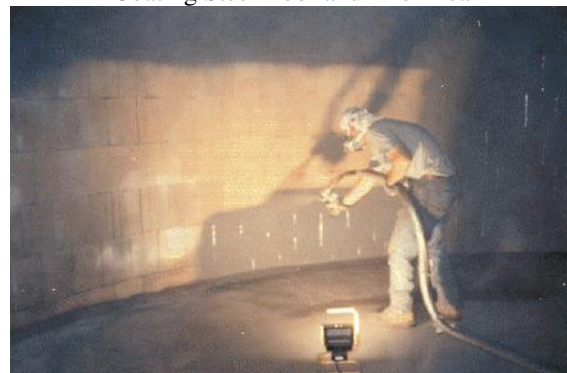
Finishing the Walls and Interior Base
